# Effect of Gear Composition and Soil Interaction on Surface Wear of Worm Gear of Self Propelled Rotary Hoe

**Abstract** | This study was conducted on a self-propelled locally made rotary hoe to overcome a problem of frequent transmission failure. The machine is used for mechanical weed control and hoeing. It was observed that the worm gear used in its transmission often failed due to surface wear of gear teeth. Worm gears made from three different copper alloys were tested against soil resistance in sandy loam soil bin. The gears were formed of commercial gun metal (Cu 87.76%, Sn 7.74, Zn 1.52%), gun metal (Cu 88%, Sn 7.38%, Zn 1.78%), and gear bronze (Cu 85.92%, Sn 4.96%, Zn 2.93%, Ni 1.23%). The gear compositions were determined using atomic absorption. The gears under test exhibited significant difference in surface wear among each other. As compared to gear bronze commercial gun metal and gun metal showed surface wear of 245% and 109% respectively. The highest surface wear was observed in commercial gun metal whereas lowest surface wear was observed in gear bronze. It was concluded that gear bronze may be the best material composition for use in the worm gear of the rotary ho

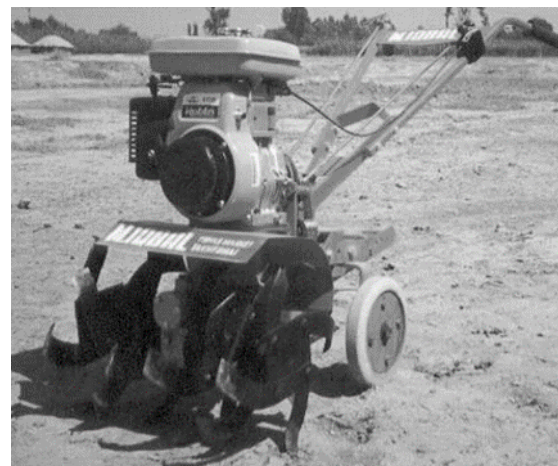
**Figure 1:** Rotary hoe manufactured in Takht Bhai, Mardan

Agricultural Light Engineering Programme (ALEP) Mardan, through its client customer workshop developed a self-propelled hand held machine for the purpose known as rotary hoe as shown [Figure 1](#). It can inter hoe row crops such as vegetables, maize, tobacco, and sugarcane. The machine is powered by 5 hp engine. Its rotary cutter L-shaped blades in the front of the machine can be adjusted to the row width.

Rotary hoe under study had worm gear failure problem in the transmission box which was due to frequent failure of the gear teeth. During experiments three different gear compositions were compared for surface wear in the gear.
